20-251E

Re: **World Trade Center**
New York, New York

One World Trade Center

World Trade Center
New York, New York

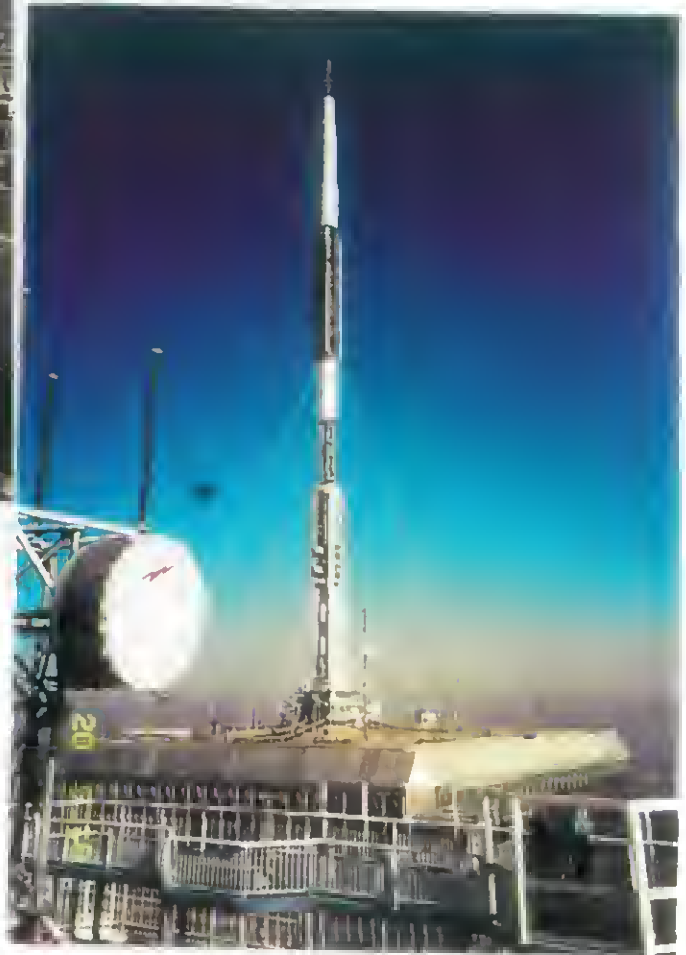
Photograph 4

Antenna

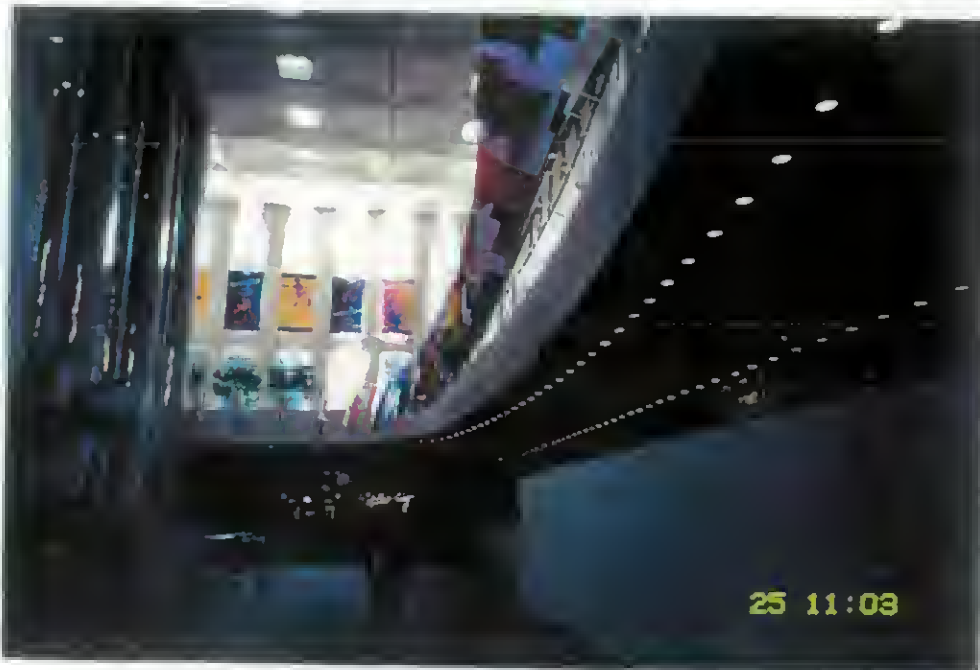
Photograph 7

Lobby with plaza
level mezzanine
above

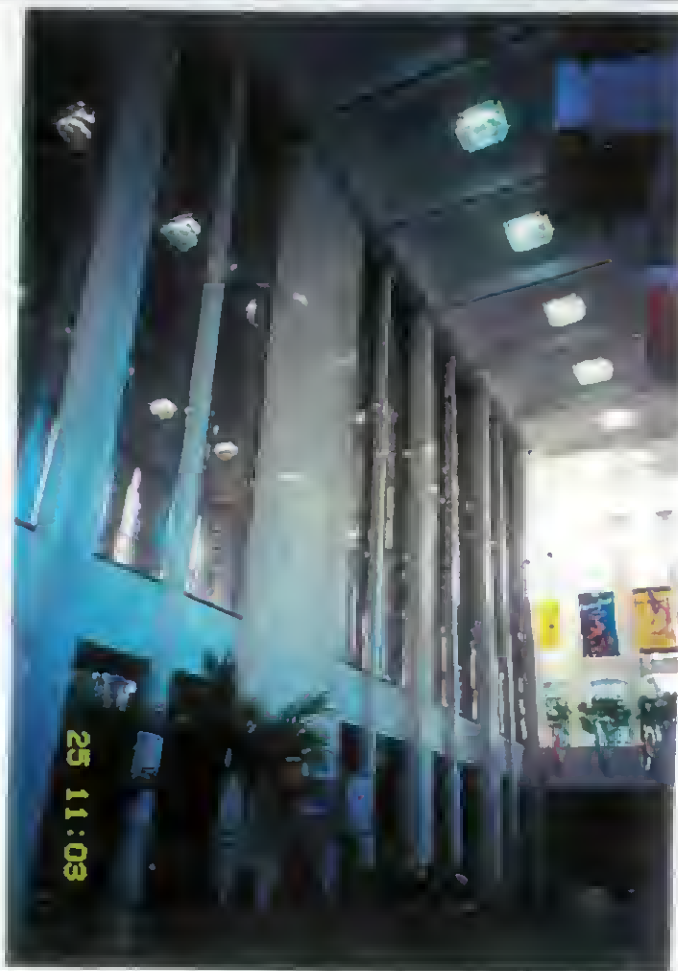
Photograph 8

Lobby and elevator
banks

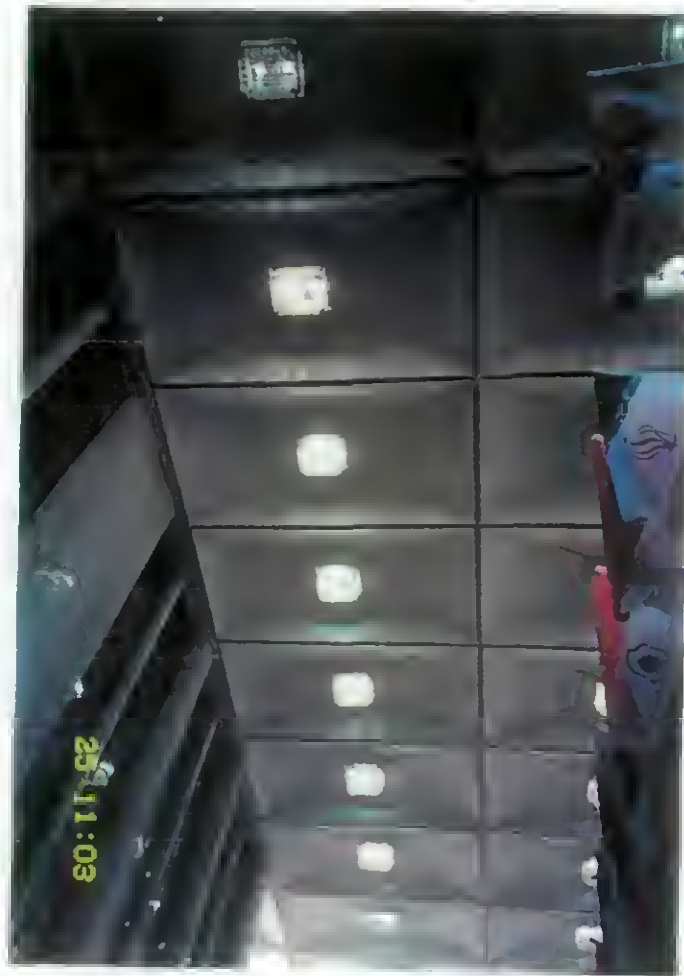
Photograph 11

Lobby suspended
plaster ceiling panels

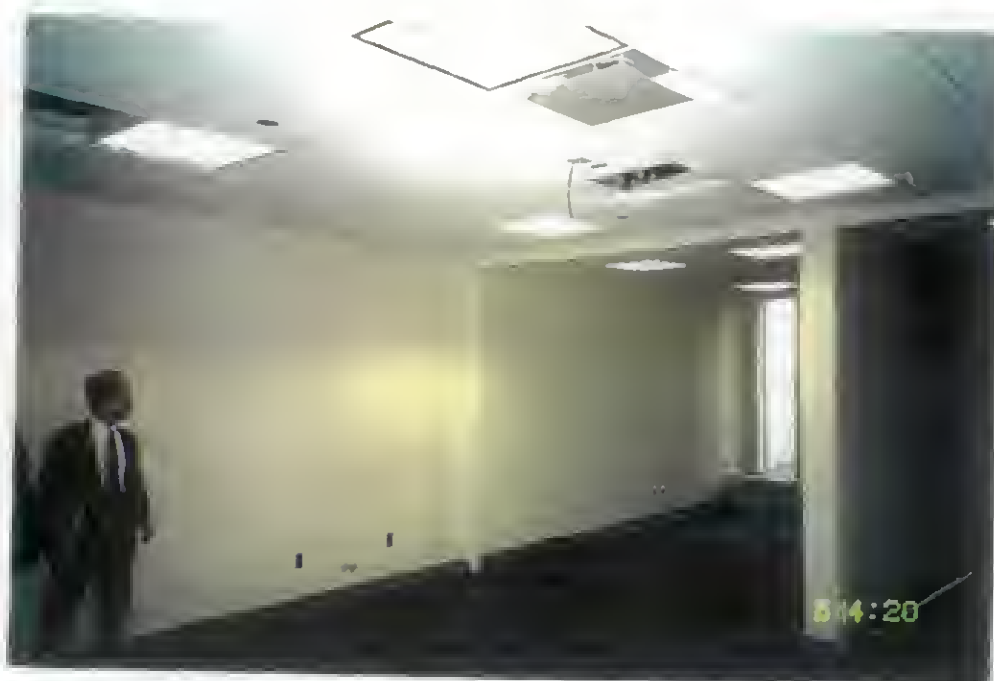
Photograph 15

Vacant space

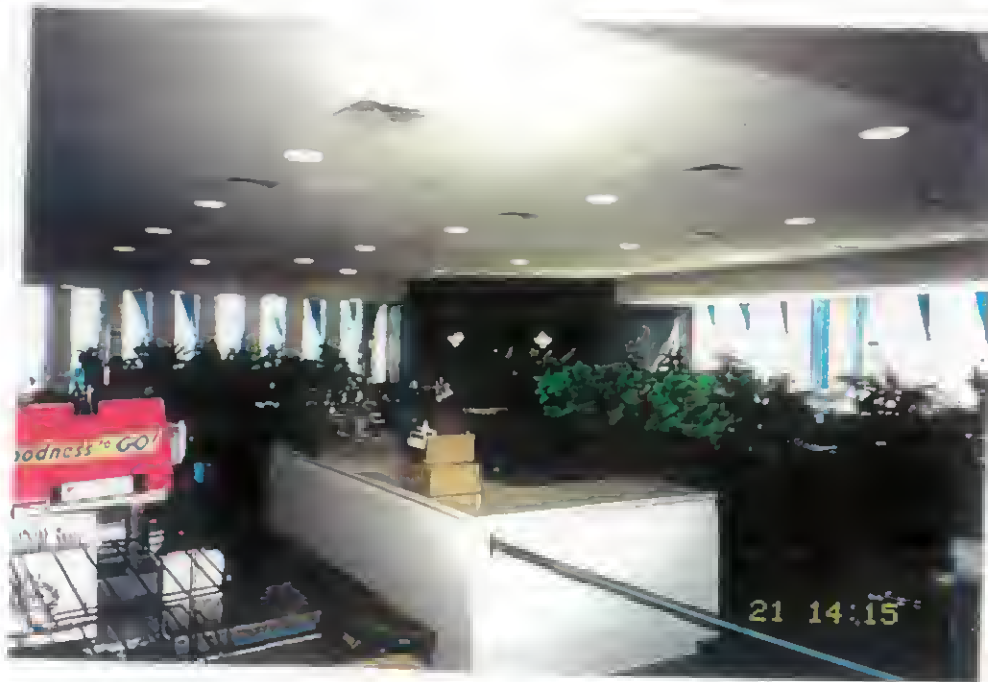
Photograph 17

Port Authority
Cafeteria on 43rd
floor

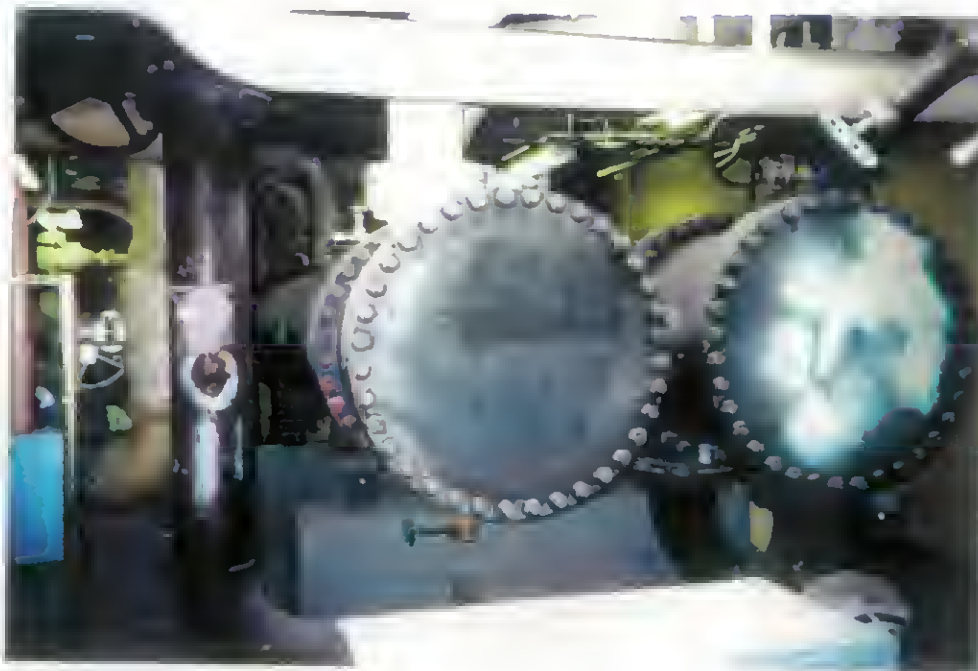
Photograph 2

Condenser water
system #2 heat
exchangers

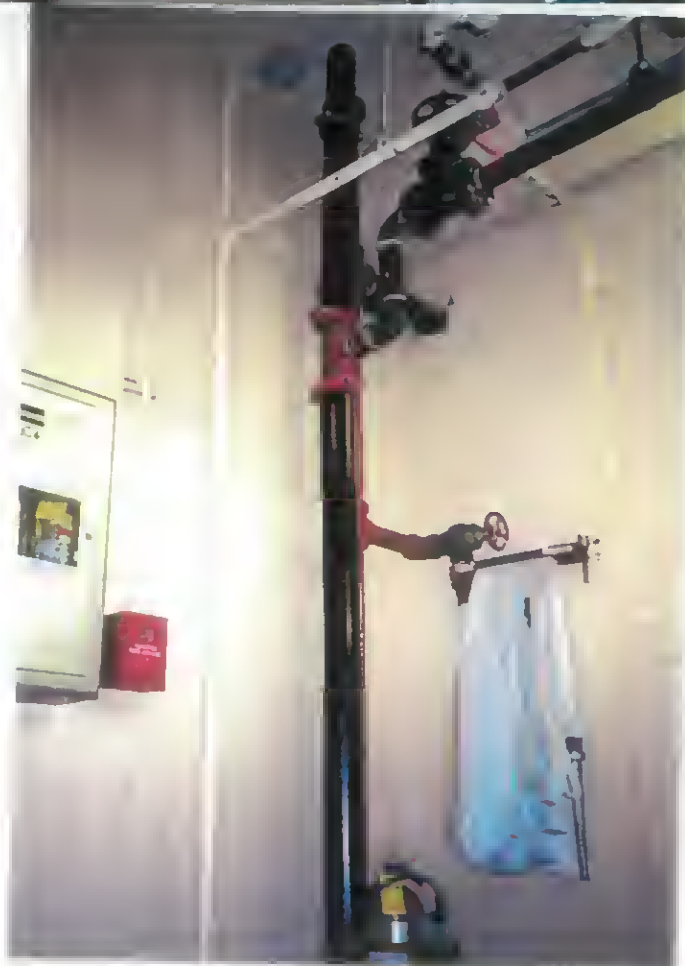
Photograph M8

Standpipe riser
with a fire hose
rack, and fire
extinguisher
cabinet located
in the stairs

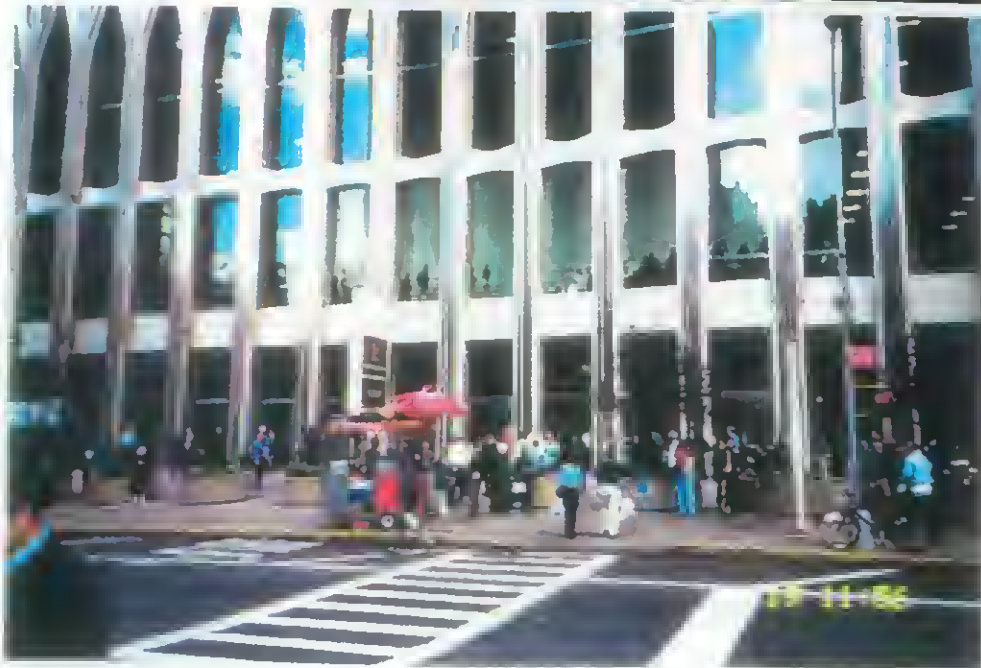
Photograph 2

Liberty Street
entrance to Lobby

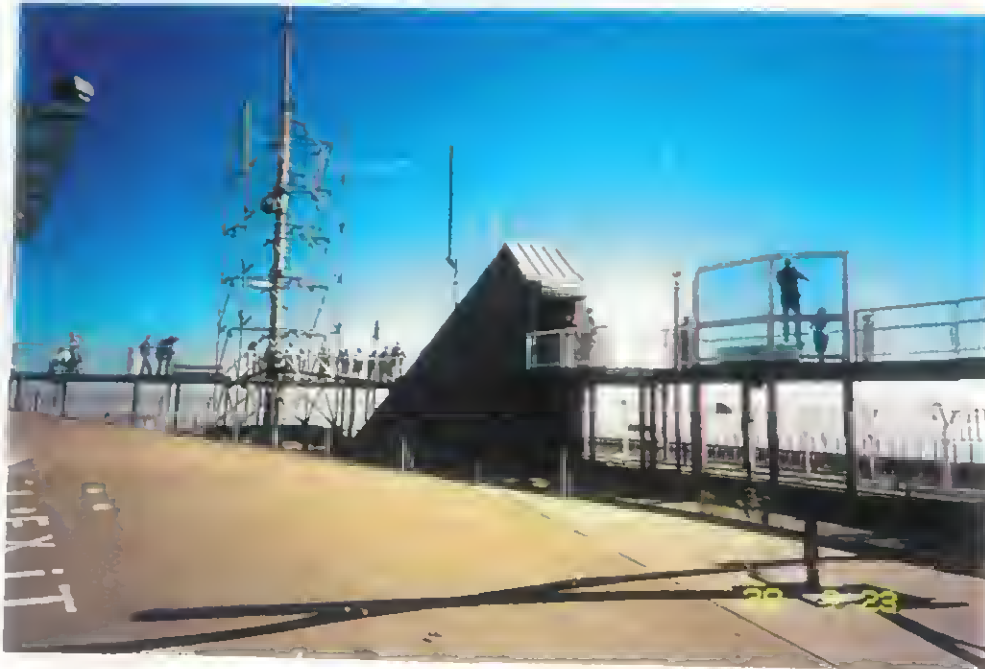
Photograph 5

Entrance to rooftop
observation deck;
note concrete
covered roof

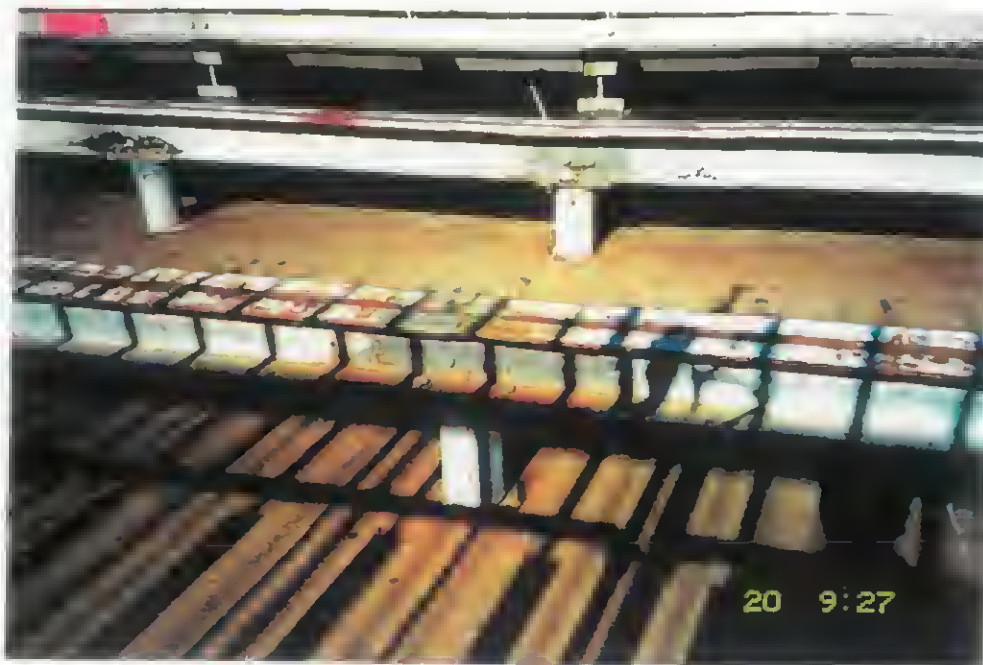
Photograph 7

Rusted window
washing rig rails

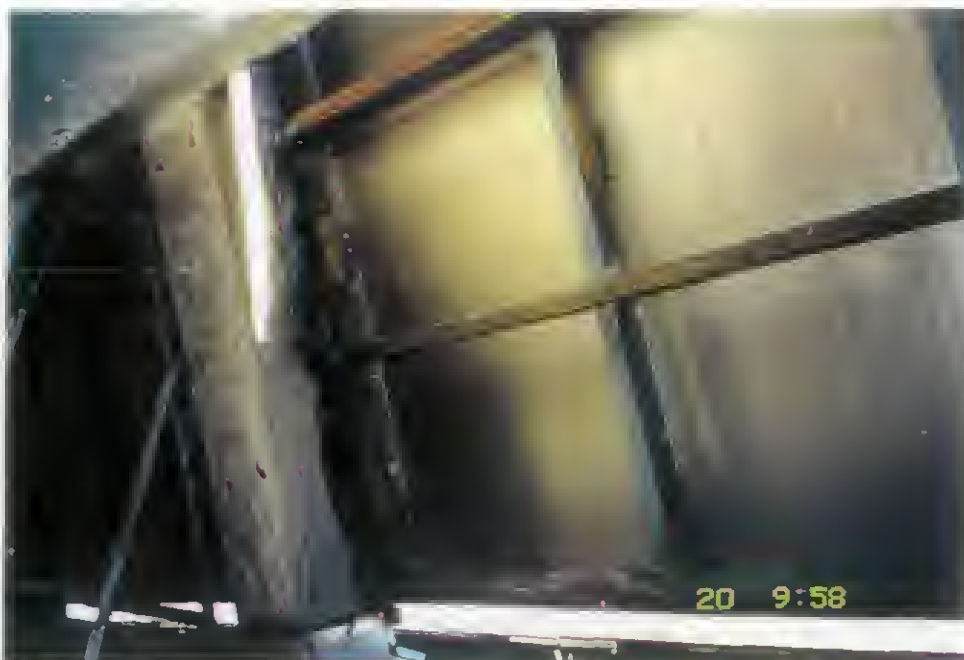
Photograph 8

Rusting purlins for
exposed facade at
110-story and at
roof

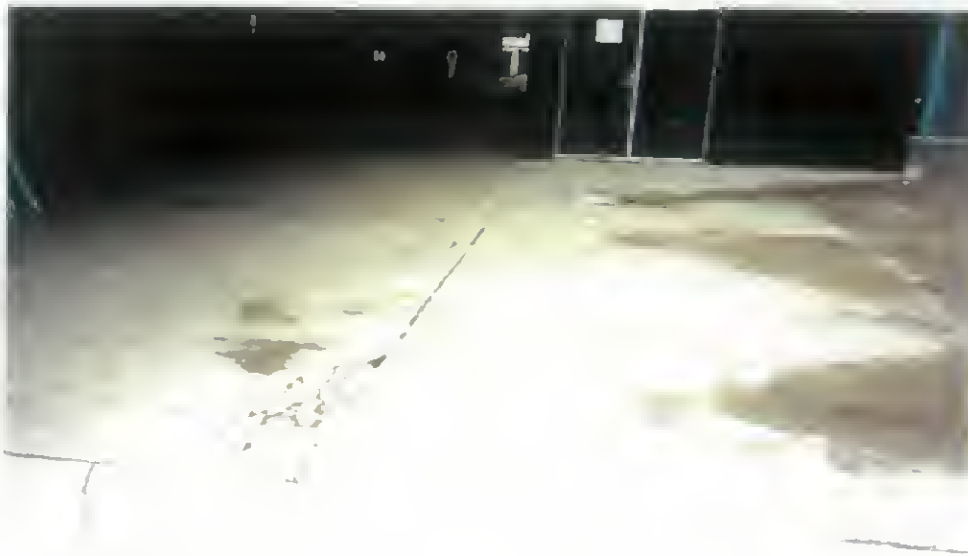
Photograph 15

**Damaged Plaza
pavement under
overhang for 4
WTC**

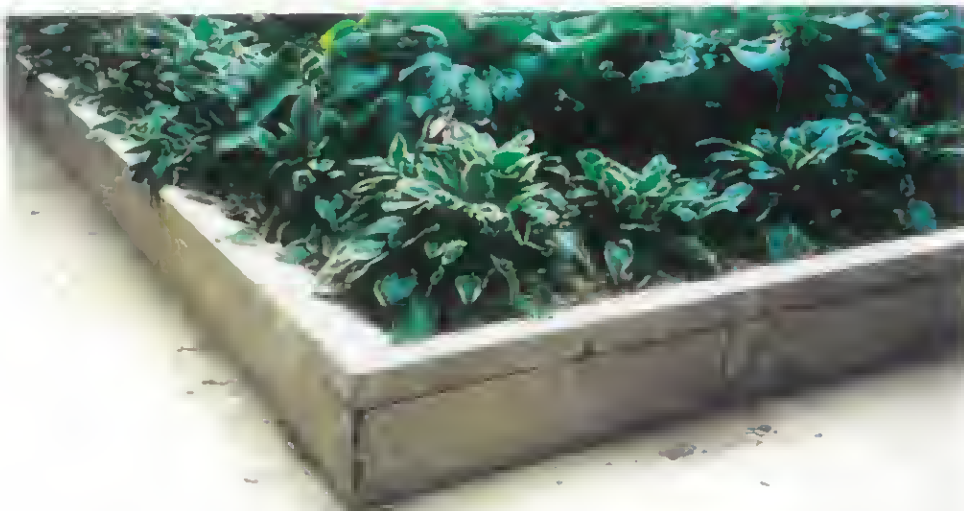
Photograph 16

**Planter damage
at Plaza level
near 4 WTC**

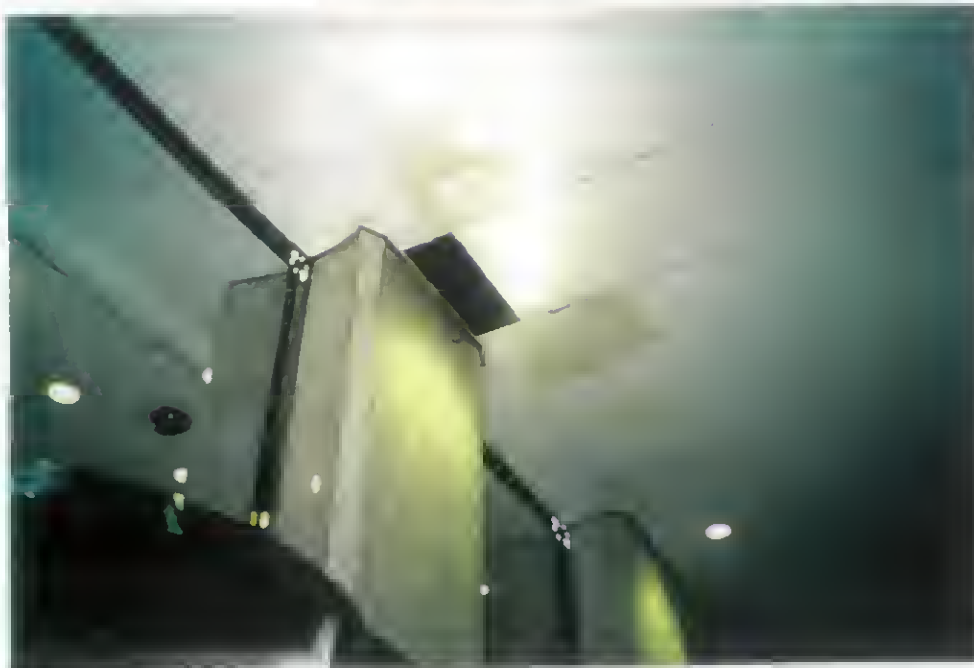
Photograph 18

**Leaks at
underside of
Plaza deck
visible near 1
WTC entrance**

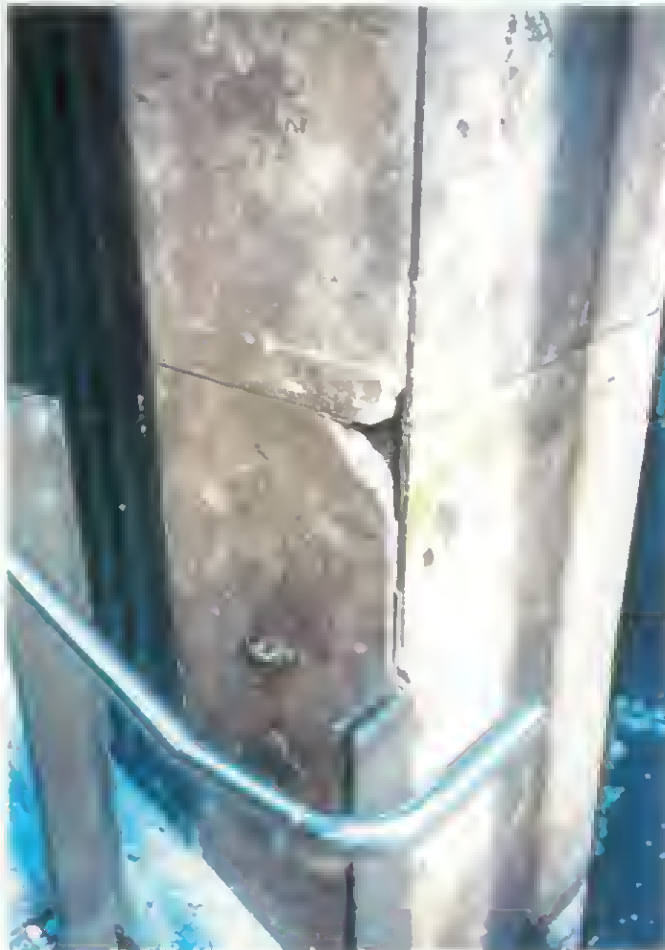
Photograph 28

**Damaged marble
panel near
bottom of
exterior stairway
between 1 and 4
WTC**

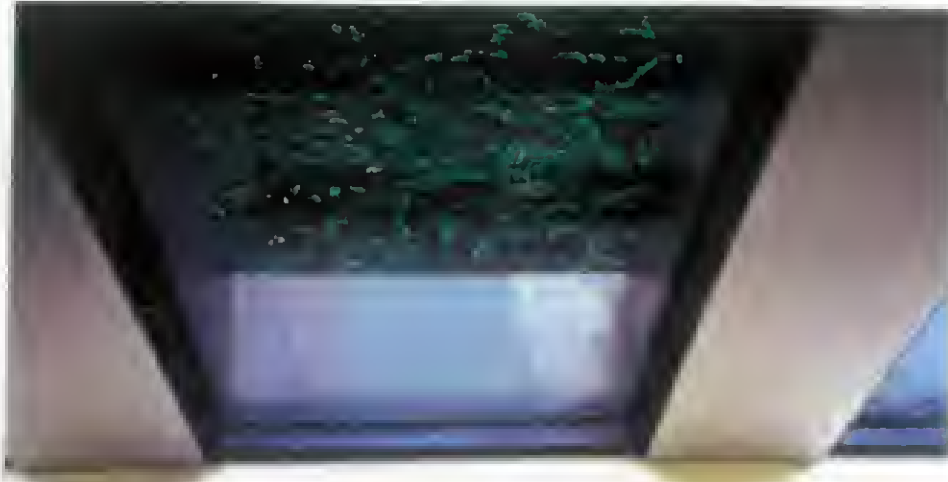
Photograph 13

**Detail of sill
condition at 4th
floor where
painted finish is
failing**

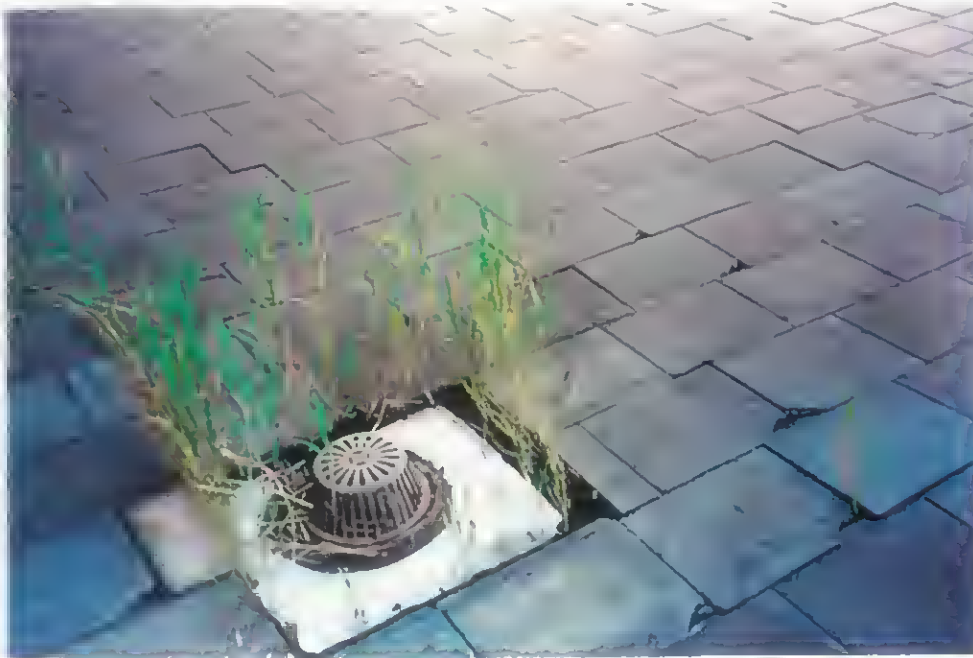
Photograph 13

Detail of roof
drain with
vegetation
growth
supported by the
moisture held in
paver backing

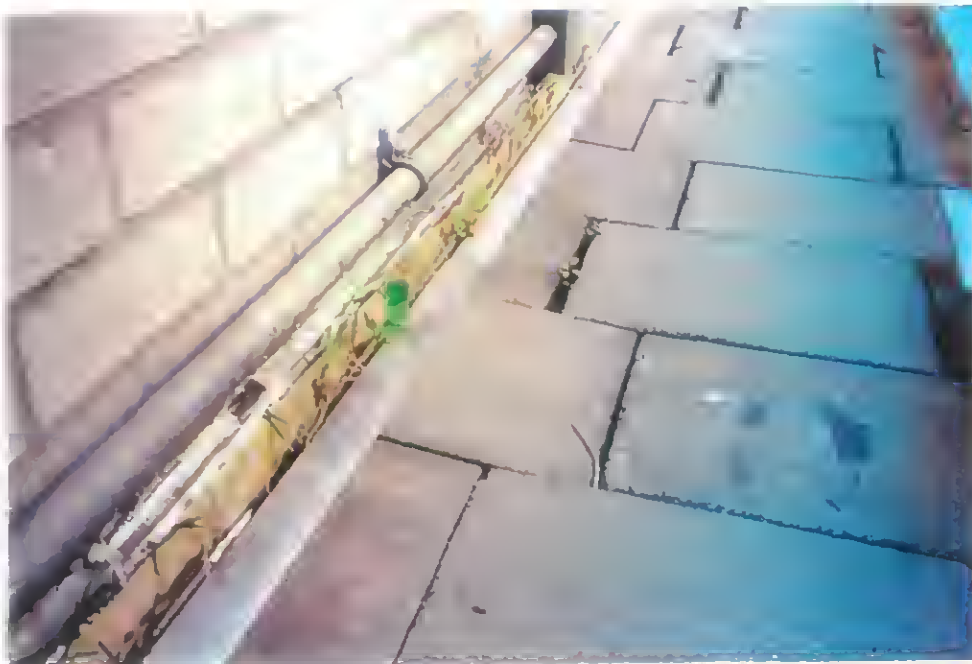
Photograph 14

Detail of
perimeter
flashing detail
with vegetation
growth

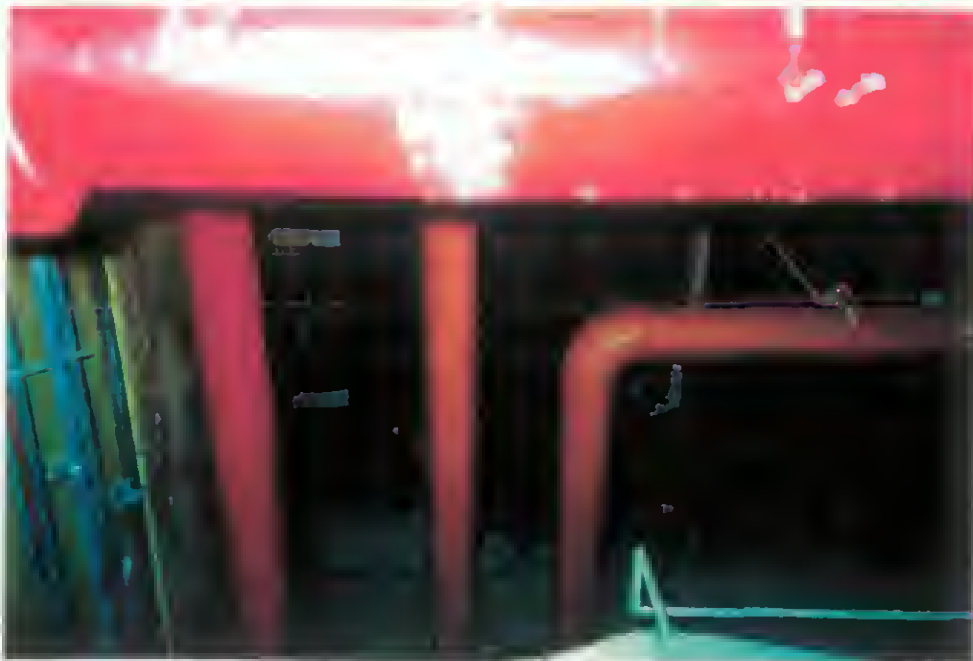
Photograph 16

**Severely rusted
underside of roof
deck from
previous roof
leaks**

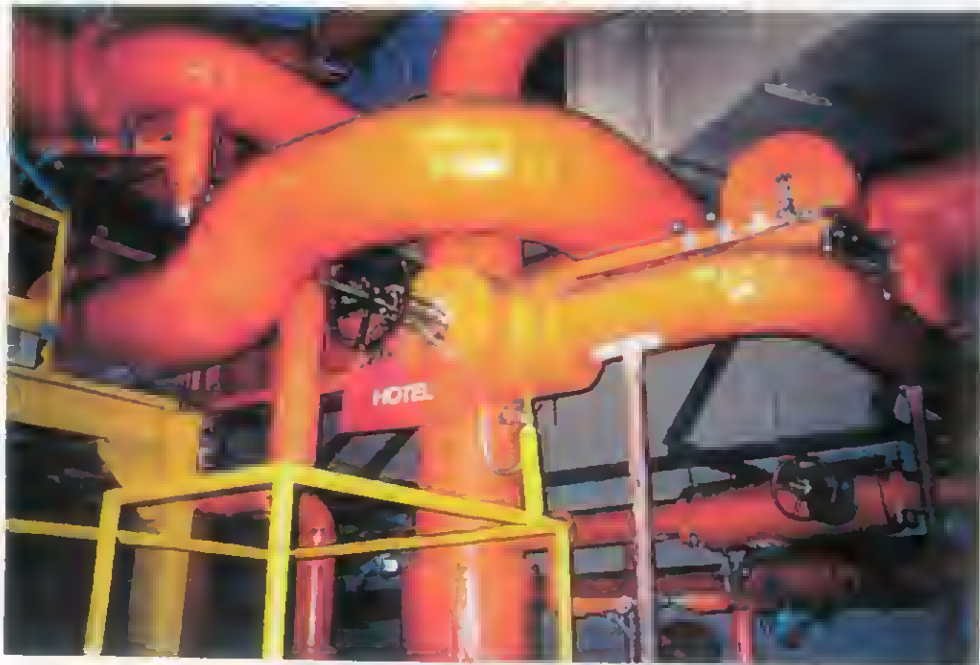
Photograph 15

Steam
distribution
plant

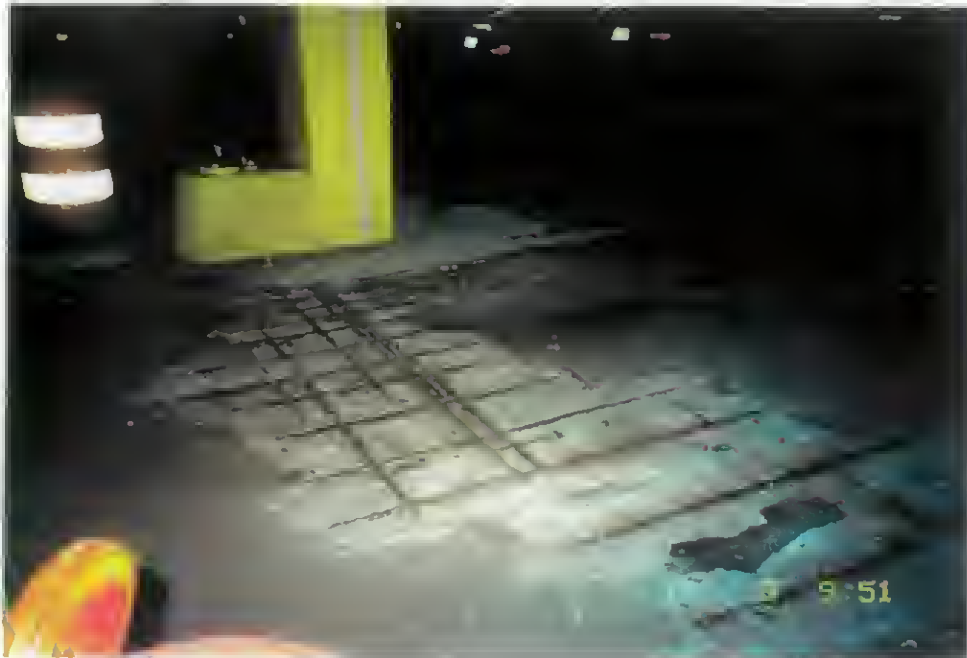
Photograph 7

Spalling garage
slab - Level 2, North

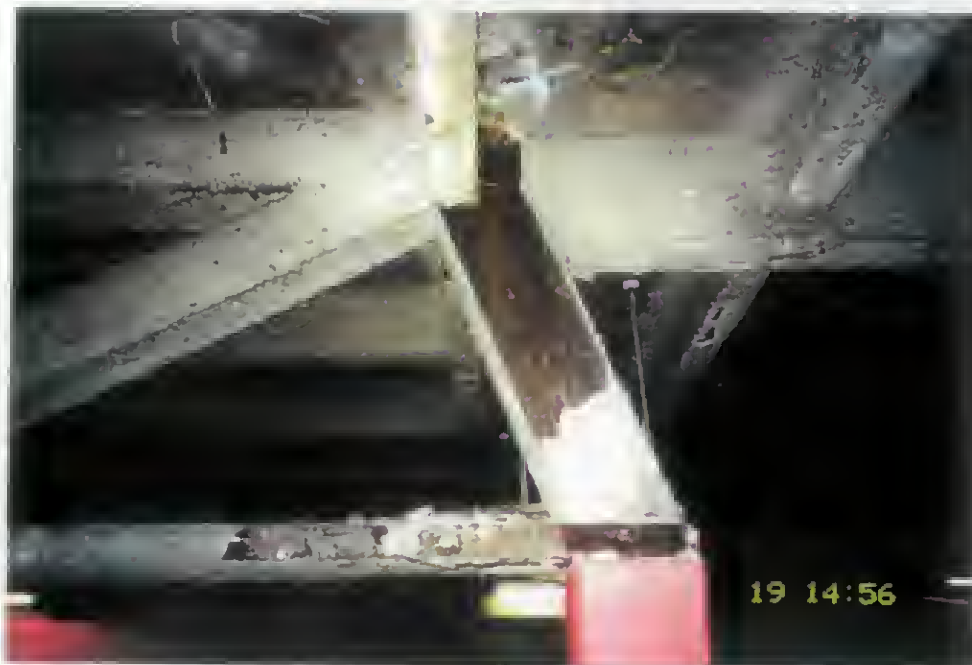
Photograph 14

Missing fireproofing
at B-2 Garage

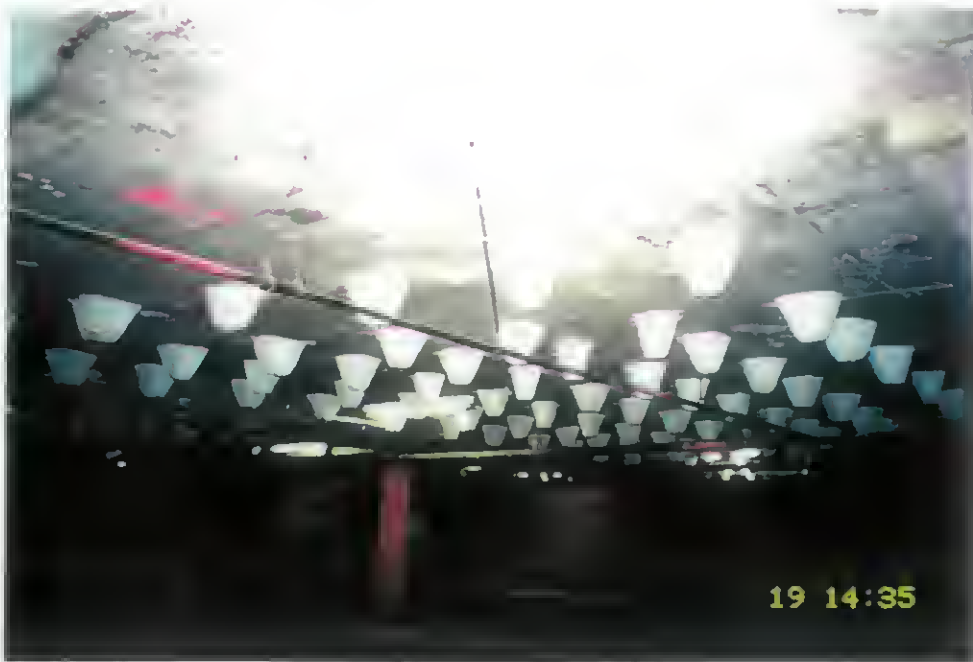
Photograph 16

Repairs of ceiling
slab at B2 ceiling
due to bomb
explosion

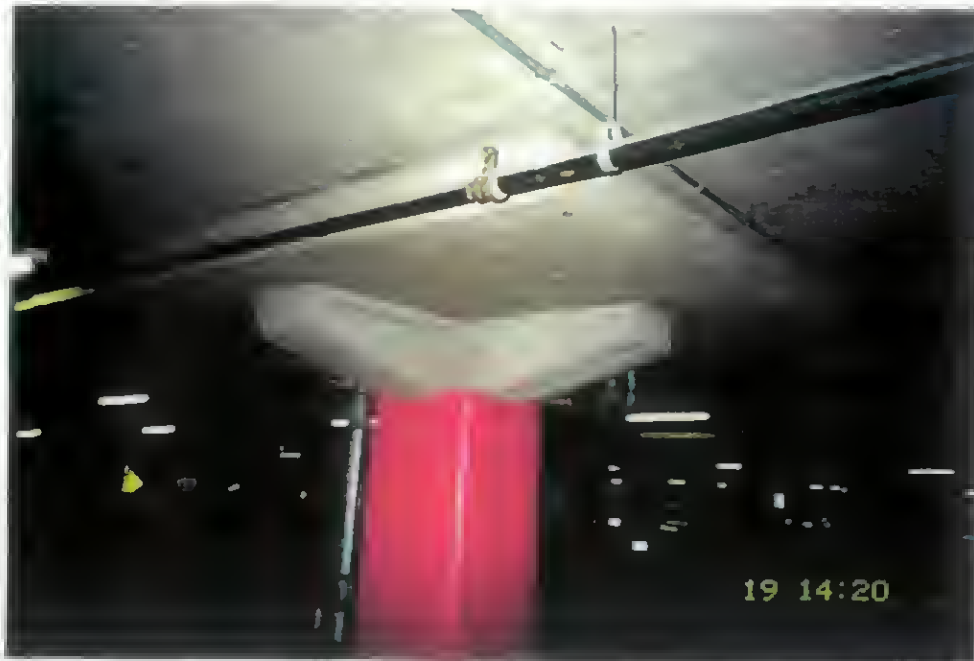
Photograph 17

Repairs at column
brackets to support
weakened slabs

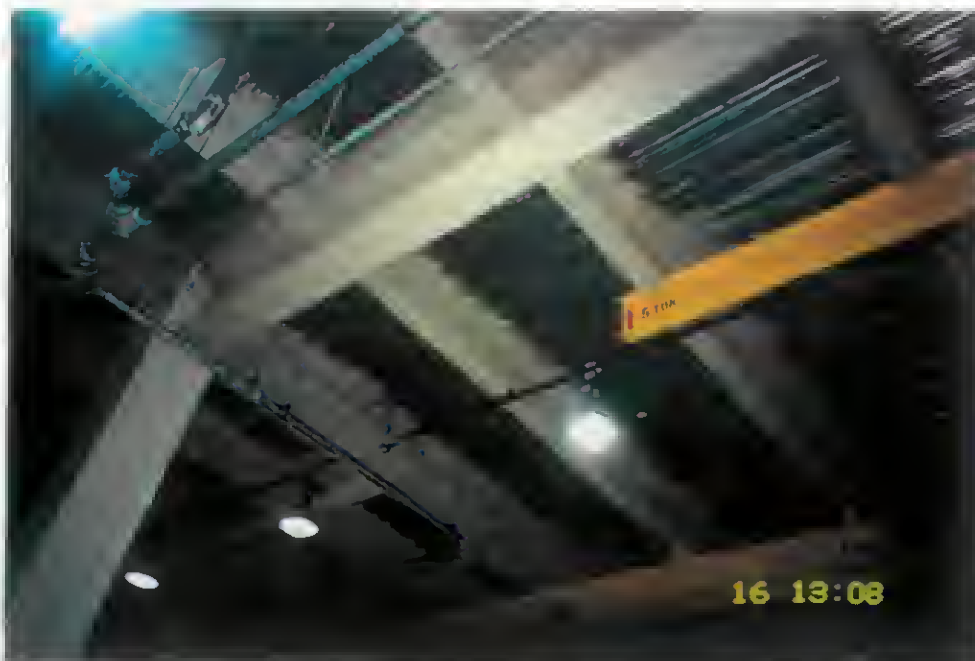
Photograph 18

New ceiling slab
installed above
refrigeration plant
due to bomb blast

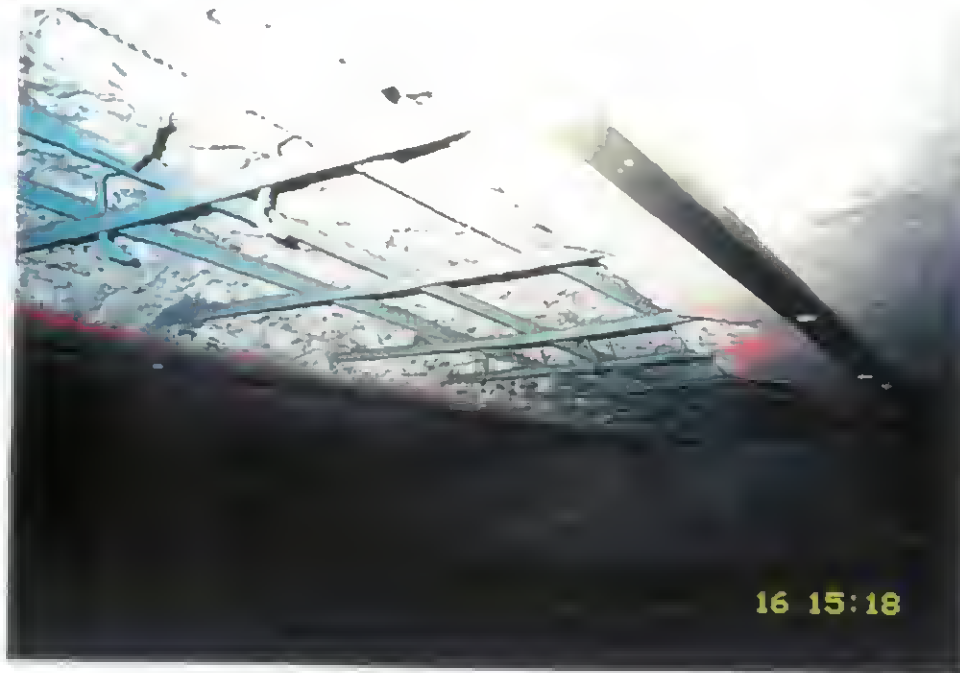
Photograph 19

Ceiling under B4
ramp (south) in
ventilation plenum
requires repairs

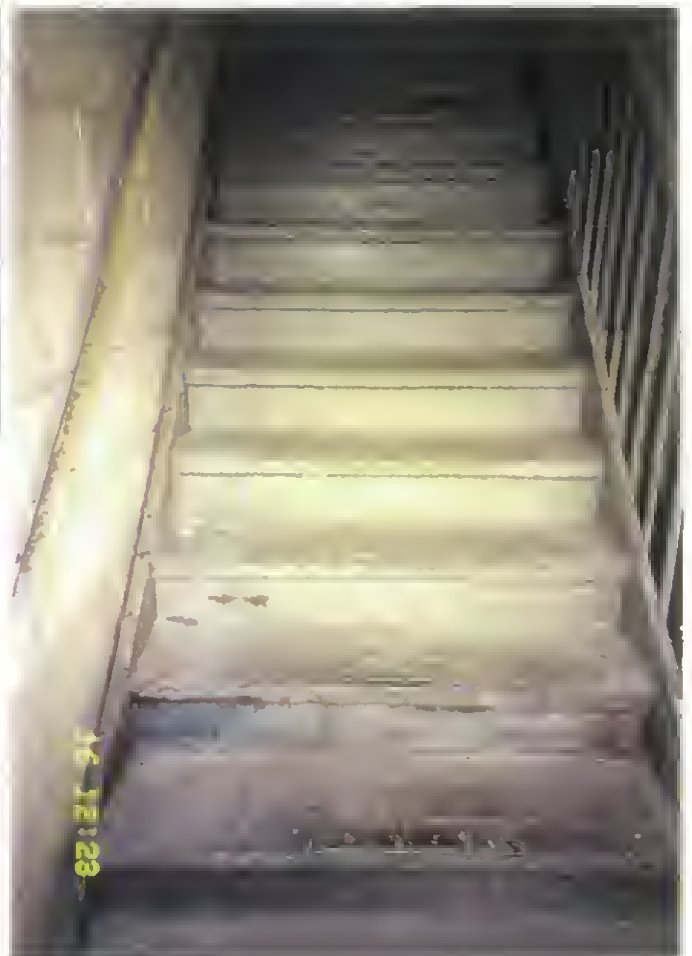
Photograph 22

Typical subgrade
stair requires
cleaning and
some require
painting

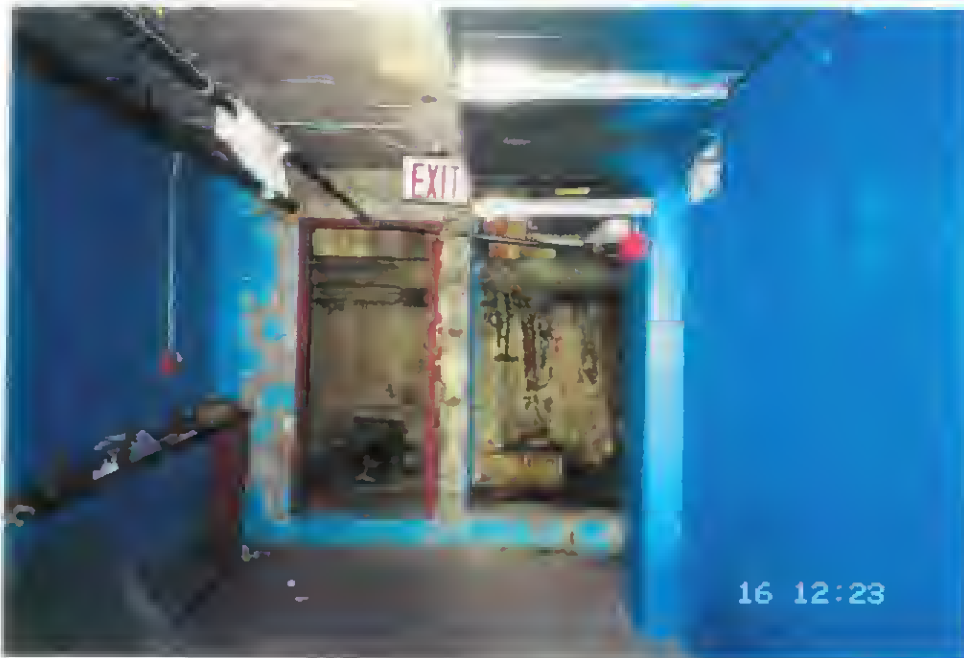
Photograph 24

B4 northeast stair
door being replaced

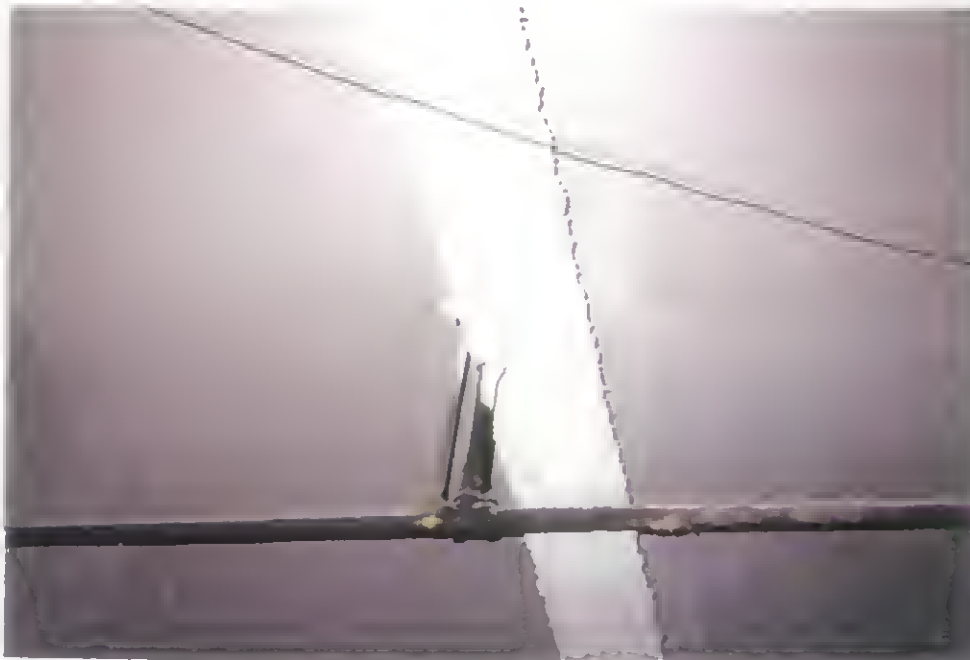
Photograph M14

Sprinkler head in
the loading dock
area observed to be
painted
